# Release Notes

## OmniAccess Stellar AP

### AWOS Release 5.0.4 MR1 - Release

These release notes accompany the OmniAccess Stellar Operating System (AWOS) Release 5.0.4 MR1 software for the Stellar APs. This document provides important information on individual software and hardware features. Since much of the information in the release notes is not included in the hardware and software user manuals, it is important to read all sections of this document before installing new hardware or loading new software.

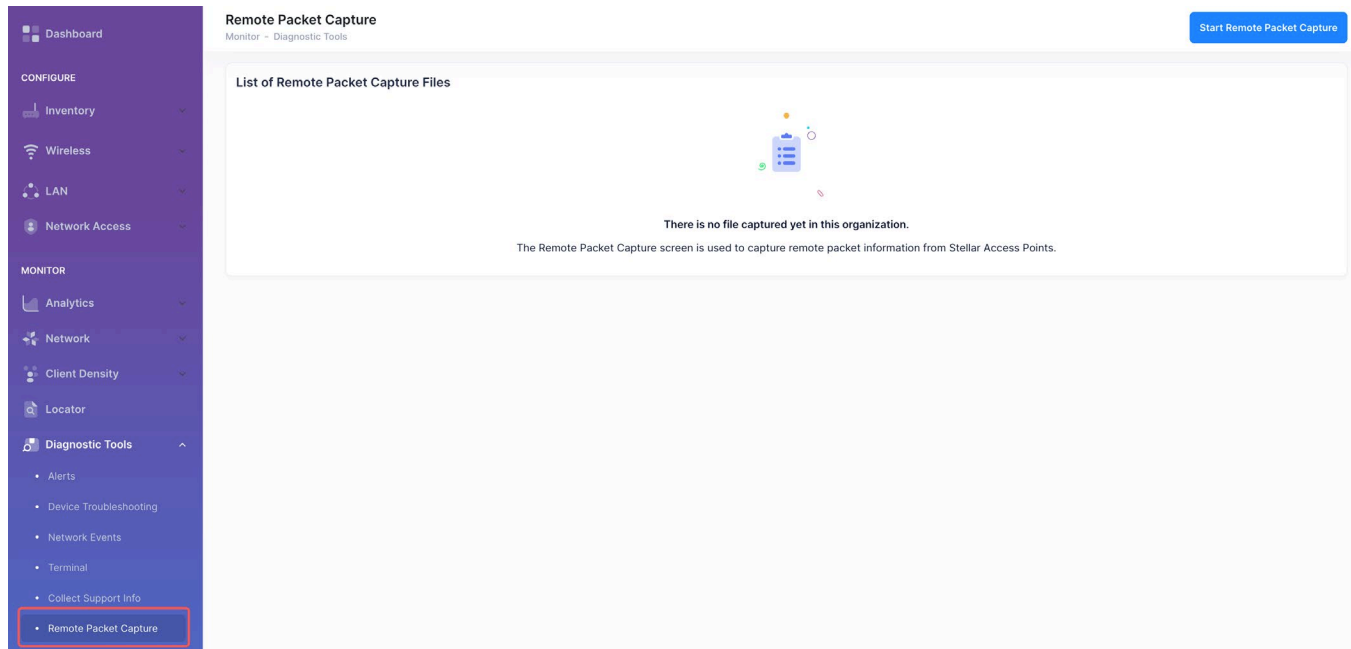
- Wireless packet capture: Supports 2.4GHz, 5GHz, and 6GHz frequency bands, with configurable channel selection.
- Wired packet capture: Supports designated network interfaces and VLAN filtering.
- Flexible filtering: Enables filtering based on MAC address, IP address, port, and protocol.

Below is the configuration display:
